Facilities Assessment

Alpha Beta Iota Fraternity

33 Bay State Road

Issued: November 5, 2017

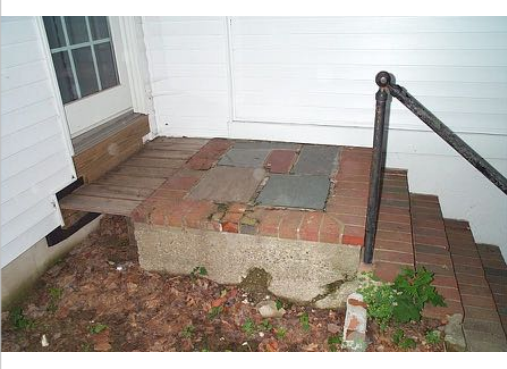
B10.1	Front brick facade.	General good condition with need for repointing (3).
B10.2	Entry stoop lacks handrail.	Install code-compliant handrail.(1)

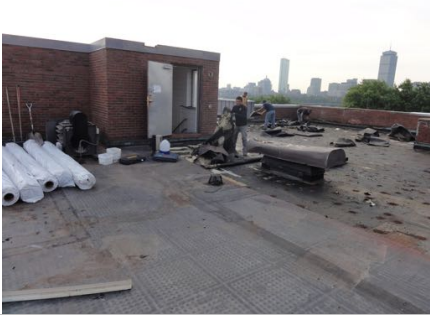
B30.1	Roof in bad repair with multiple bare spots and no insulation.	Replace roof and add new insulation. (1)

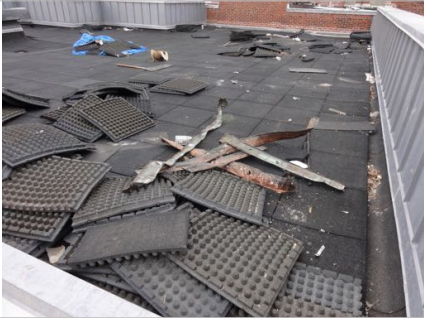
B30.2	Rubber deck is coming off.	Reattach rubber roof tiles.(2)

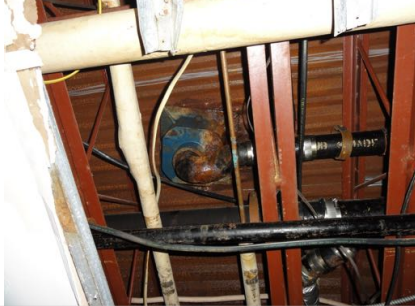
C10.1	Wood stud walls.	In good condition, straight and true. (N)
C10.2	Bunkroom (501) ceiling joists at roof drain show rust.	Evaluate, repair, and finish with rust inhibitor.(2)

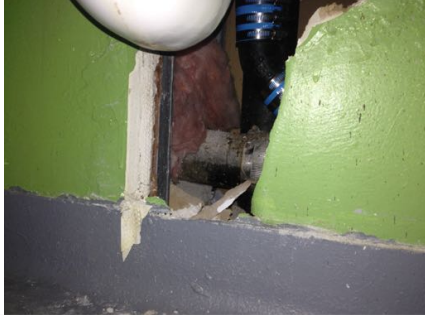
C10.3	Kitchen (001) wall at sink is wet.	Repair leak, remove moldy wood, refinish. (1)

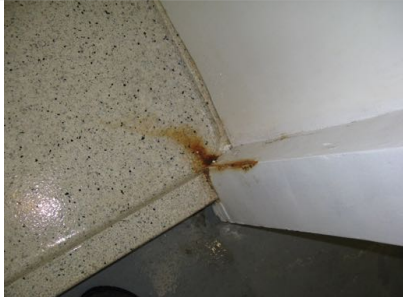
C30.1	Plaster on wood lath.	Good condition, straight and true.(N)
C30.2	Bath (306) shower pan is leaking.	Replace shower pan. (1)

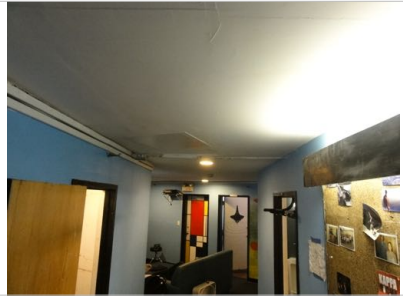
C30.3	Recreation Room (001) ceiling cracked.	Remove bad plaster and refinish. (3)

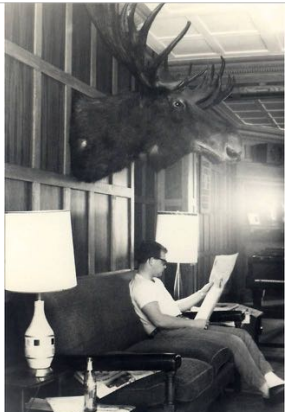
C30.4	Large moose head in Living Room (101) held up with clothes hanger.	Remove immediately, mount head with proper fasteners.(1)

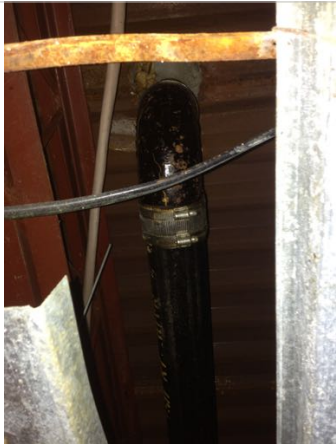
D20.1	Copper supply lines.	Appear to be in good condition.(N)
D20.2	Cast Iron roof drain has leaks.	Cut and replace bad sections. (1)

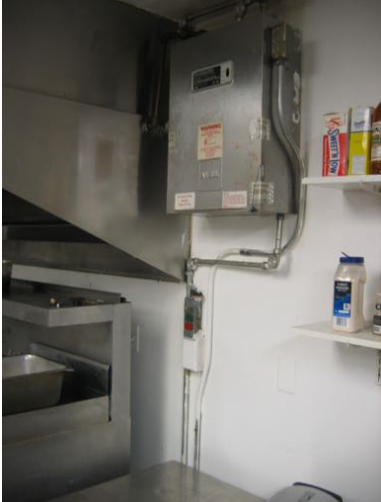
D40.1	Copper sprinkler pipes have chronic pinhole leaks.	Replace with cast iron sprinkler pipes. (2)
D40.2	Stove hood no longer operates.	Replace motor. (1)
D40.3	Stove hood lacks CO shutoff.	Install shutoff. (1)

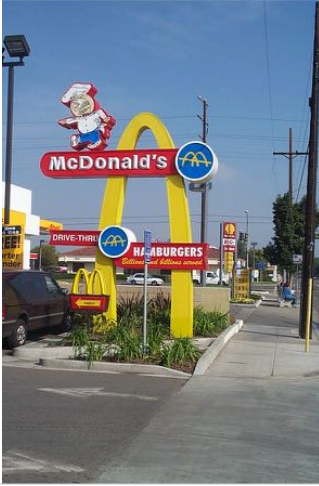
D50.1	Electrical outlets number and placement is inadequate in bedrooms and studies. Multiple extension cords observed.	Upgrade bedroom electrical systems.(1)
D50.2	Fast food sign is antiquated neon.	Replace with LCD signage.(3)
